TECHNICAL NOTE

MRL-TN-504

GRINDING OF STEEL - A CASE STUDY

A description is given of grinding studies aimed at overcoming a production problem on the dry grinding of hardened steel gears for aircraft gas turbine engines, in which grinding abuse in the form of both a softening and hardening of the steel led to high rejection rates. By using a combination of reduced grinding wheel speed and graded finishing cuts, gears could be produced without showing any signs of grinding abuse.

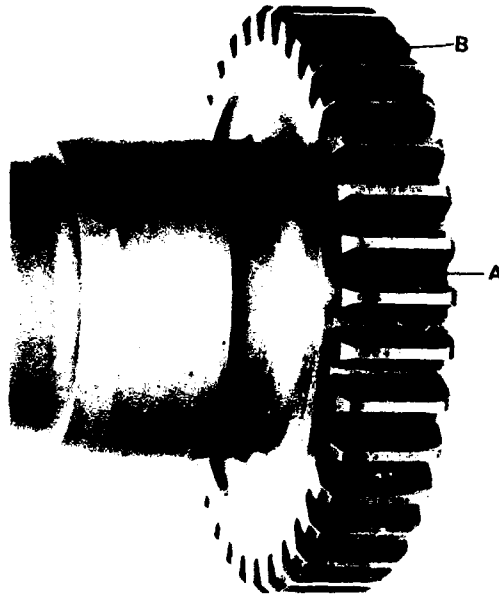
The present investigation concerned a production problem in the grinding of gears for the gas turbine engine of a military aircraft. The gear, shown in Fig. 1, is made of a 3% nickel-chromium-molybdenum case-hardening steel, the specified case hardness being 58-63 RC (650-770 HV). The gear is driven by the engine compressor through a gear train and transmits the power required (about 150 KW (200 HP)) for the major engine accessories, such as fuel and oil pumps. Any tooth failure would therefore be catastrophic. Accordingly, the acceptance standard is very high and each gear is subjected to a nital-etch test (2% nitric acid/98% ethyl alcohol solution) after the final grinding operation to reveal any grinding abuse in the form of softening and/or hardening.

A gear showing grinding abuse revealed by the etching is exemplified in Fig. 1, where the dark-etching areas in the roots (A) and on the flanks (B) of the teeth are indicative of grind softening. In some cases there were also white to near white etching areas associated with the dark-etching areas, which are indicative of grind hardening. A taper section through a tooth (Fig. 2) shows the corresponding changes in the microstructure, consisting of an outer white-etching transformed layer, which results in hardening, together with an underlying dark-etching softened layer caused by overtempering. For comparison, the case hardness was 710 HV while the hardness of the white-etching layer was 840 HV and that of the dark-etching layer 550 HV.

FIG. 1 Photograph of gear, showing dark-etching regions in the roots (arrow A) and on the flanks (arrow B) of the teeth which are indicative of grind softening.  $\times 1\frac{1}{2}$

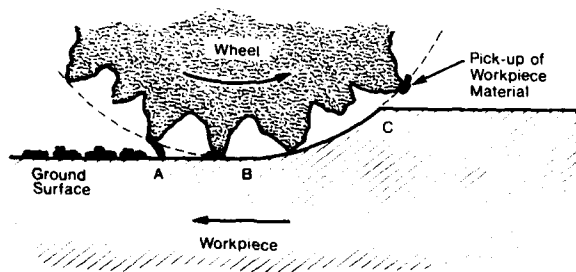
To first ascertain the material aspects associated with dry grinding, a tooth of a reject gear was ground on a surface grinder at MRL under similar conditions to those used in production with respect to wheel grade, wheel speed and feed. Two cuts of 25  $\mu\text{m}$  (0.001 in) were made followed by one of 5  $\mu\text{m}$  (0.0002 in), beginning with a freshly dressed wheel. The general appearance of the dry ground surface is shown in Fig. 3. The surface finish is poor, a particular feature being the presence of discrete pieces of metal adhering to the surface together with what appear to be smeared surface layers. This type of surface is similar to that previously found on ground 70/30 brass (1), which was attributed to a redeposition process depicted schematically in Fig. 4. It was suggested (1) that metal is picked up on some grits as they pass through the cutting zone BC and then is redeposited back onto the workpiece surface just prior to the grits re-entering the cutting zone. The region where redeposition from the wheel starts to occur is indicated by A. Progressing further towards the beginning of the cutting zone B the angle of approach between the wheel and workpiece decreases, and metal redeposited in this region is subjected to increasing amounts of plastic deformation and smearing.

FIG. 4 Schematic illustration of the redeposition process. Redeposition starts at A, smearing of redeposited metal occurs between A and B, and B-C is the cutting zone.

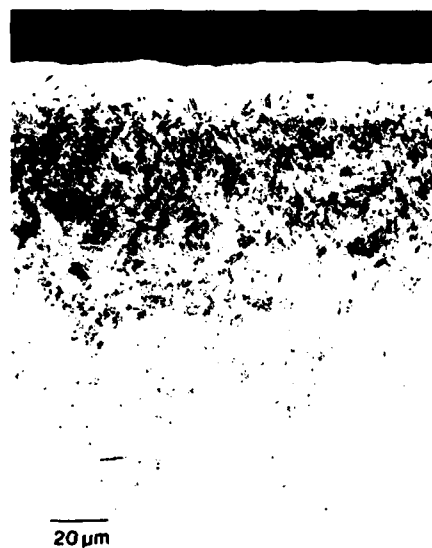
FIG. 7      Optical micrograph through surface corresponding to Fig. 6, showing a white-etching layer and an underlying dark-etching layer (cf. Fig. 5).

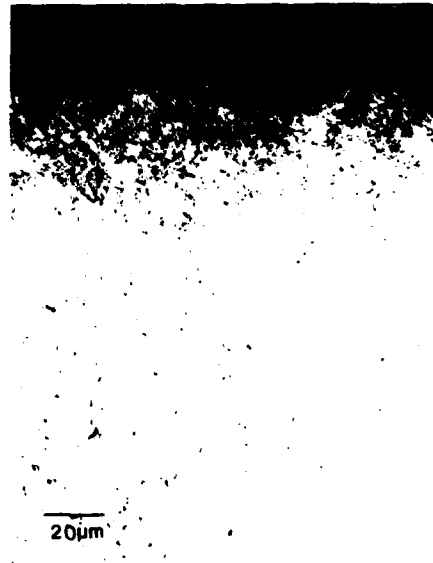
The extent of damage at the lower wheel speed (Fig. 9) indicates that it emanated primarily from the roughing cuts, which would not have been removed by the few finishing passes of  $5\text{ }\mu\text{m}$  ( $0.0002\text{ in}$ ) used in production. The surface grinding studies revealed that, if the roughing cuts were stopped  $100\text{ }\mu\text{m}$  ( $0.004\text{ in}$ ) oversize and the finishing cuts were graded down to  $2.5\text{ }\mu\text{m}$  ( $0.0001\text{ in}$ ), there was then no evidence of any change in the workpiece microstructure, as shown in Fig. 10.

FIG. 9      Optical micrograph through surface corresponding to Fig. 8, showing only a relatively shallow dark-etching layer which should be compared with Fig. 5.

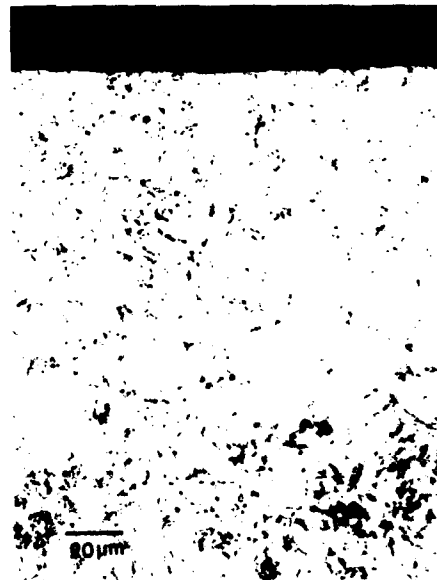
FIG. 10      Optical micrograph through surface after grinding dry at a wheel speed of 18 m/s with graded finishing cuts. There is no detectable change in microstructure.

(i) dressing the wheel after the roughing cuts and taking four cuts of  $12.5\text{ }\mu\text{m}$  ( $0.0005\text{ in}$ ), (ii) taking five cuts of  $5\text{ }\mu\text{m}$  ( $0.0002\text{ in}$ ), and (iii) dressing the wheel and taking ten cuts of  $2.5\text{ }\mu\text{m}$  ( $0.0001\text{ in}$ ).

The surface grinding studies showed that by using a combination of reduced wheel speed and graded finishing cuts extending down to  $2.5\text{ }\mu\text{m}$  ( $0.0001\text{ in}$ ) over a depth of  $100\text{ }\mu\text{m}$  ( $0.004\text{ in}$ ) no changes were apparent in the workpiece microstructure. Applying this procedure in production enabled gears to be ground which did not show any evidence of grinding abuse after the nital-etch test.
